Materials Testing & Consulting, Inc.

Re: Project #17B152

The following results are for pull-testing that was performed on the 5/8" F-8 Springbolt anchor system. Client had fabricated 2 concrete panels with the noted Springbolt anchor system installed using a 5000 psi bag mix. Client also delivered 2 - 4" x 8" concrete cylinders, to verify the compressive strength of the test panels.

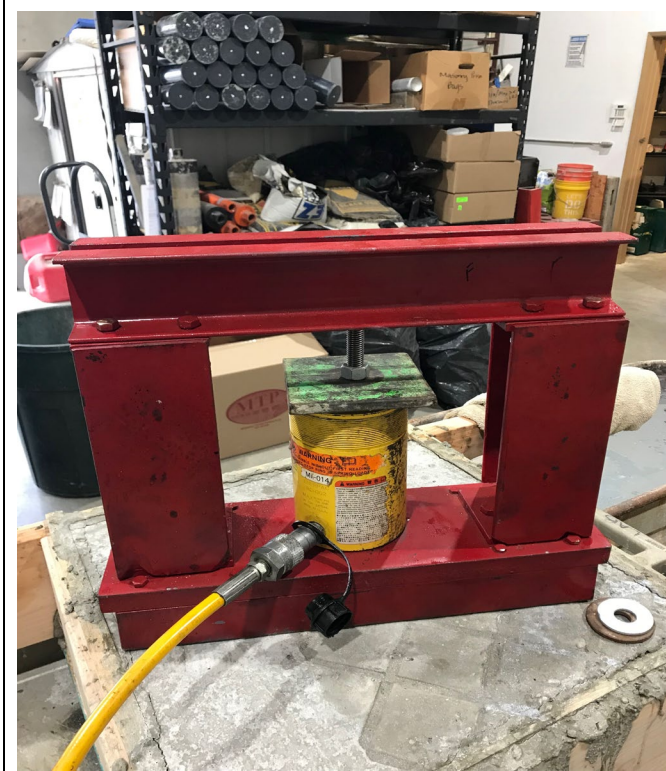
Load Assembly

Equipment Used for Test: Enerpac P-392 Pump with a Enerpac RCH-302 hollow-core ram
Verification Date of Equipment: May 14, 2018
